construction
engineering
research
laboratory

TECHNICAL REPORT M-258
April 1979

FRACTURE CHARACTERISTICS OF
STRUCTURAL STEELS: REFERENCE MANUAL

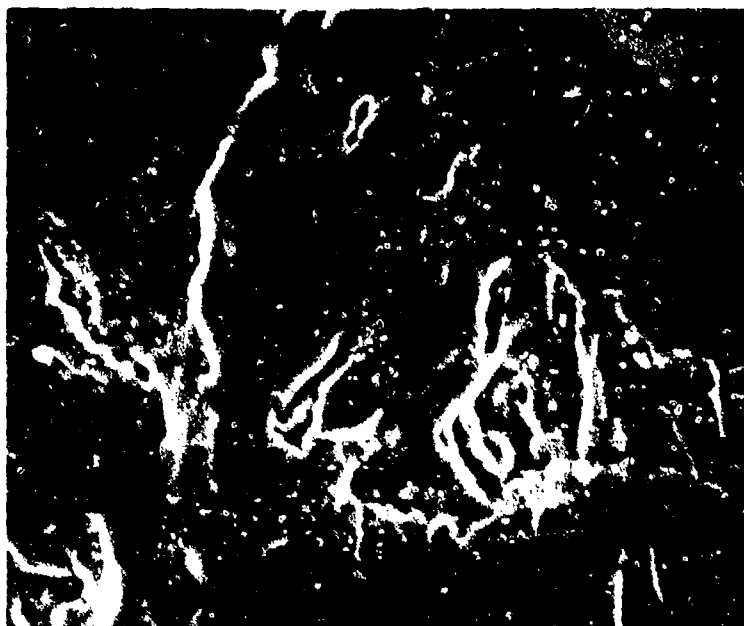
The fracture surfaces of the 17-4PH fatigue specimens tempered at 482°C (Figure 239), or 538°C are all quite flat. Failure occurred by quasi-cleavage (Figure 240) in all three specimens. The 482°C and 538°C specimens had dark areas on the low magnification micrographs which at higher magnification was shown to be unusually flat regions (Figure 241). The appearance of this area indicated that a very low energy fracture occurred through a very brittle material or interface, probably some kind of inclusion.

Figure 241. Brittle inclusion in a 17-4PH fatigue specimen aged at 538°C, 2500x.

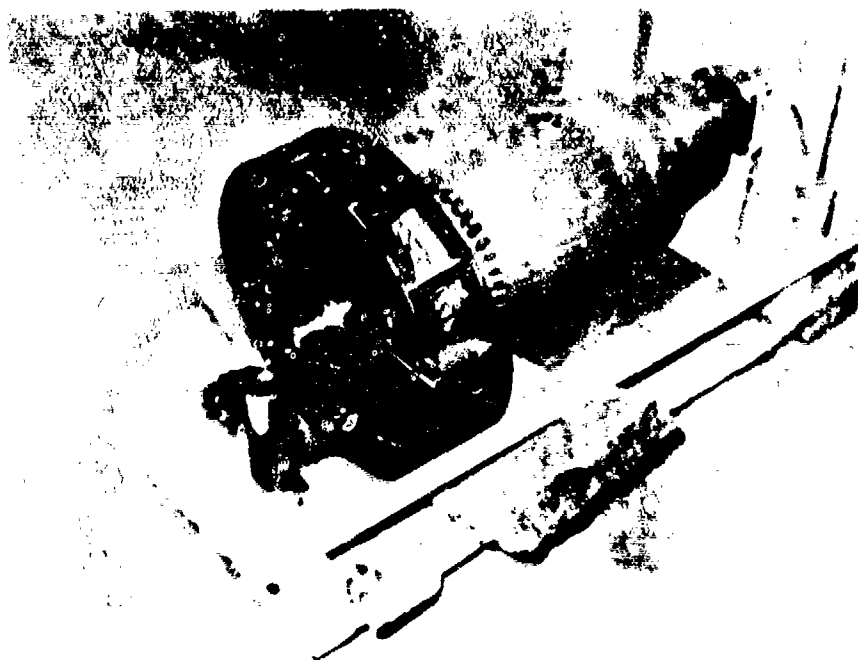
The entire shaft assembly after shipment to CERL is shown in Figure A1. The failure appeared typical of rotating bending fatigue fractures. In the general area of the failure there were no nicks, tool marks, etc., which would indicate abuse. There was no evidence of corrosion. The fracture surface consisted of a dull "off center" ductile fracture surrounded by high cycle fatigue markings. The shaft broke at the fillet, which is vulnerable to fatigue crack failure because the stress concentration is high. The keyway stops 1-1/2 in. (3.81 cm) before the fillet, which is a good design practice, otherwise the keyway would cause even more stress concentration.

Figure A1. Failed exciter shaft as received by CERL.

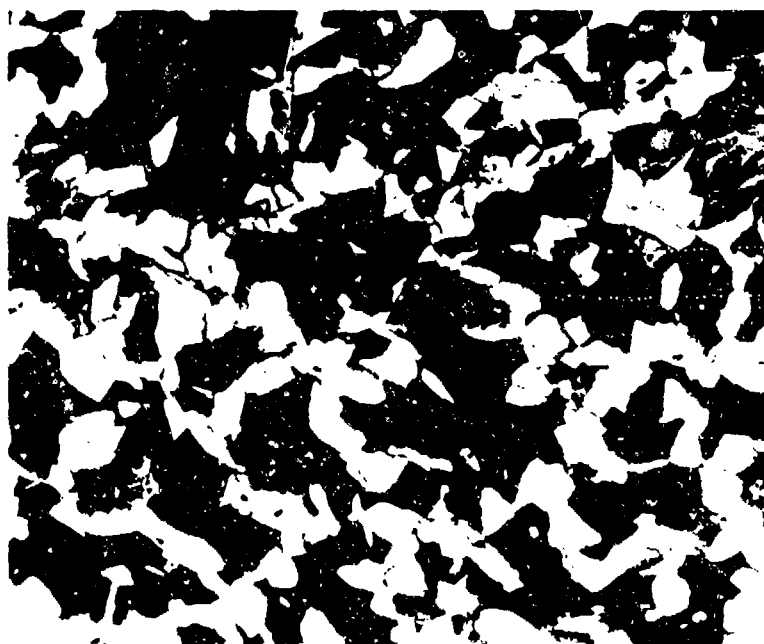
A portion of the shaft was cut off, polished, and etched for metallographic observation. The microstructure is shown in Figure A6. The microstructure of the base metal (Figure A6a) consists of ferrite with pearlite within the grains. The grain size as determined by standard ASTM grain size number is 3, which is a larger grain size than normally found in items of this nature. The microstructure of the weld metal is shown in Figure A6b. The microstructure shows most pearlite with a very small amount of ferrite at the grain boundaries, which is typical of the weld metal.

Figure A6. Microstructure of the exciter shaft.
(a) Near the center of the shaft (100x)
ASTM standard grain size number 3.
(b) Near the surface in the weld metal (100x).

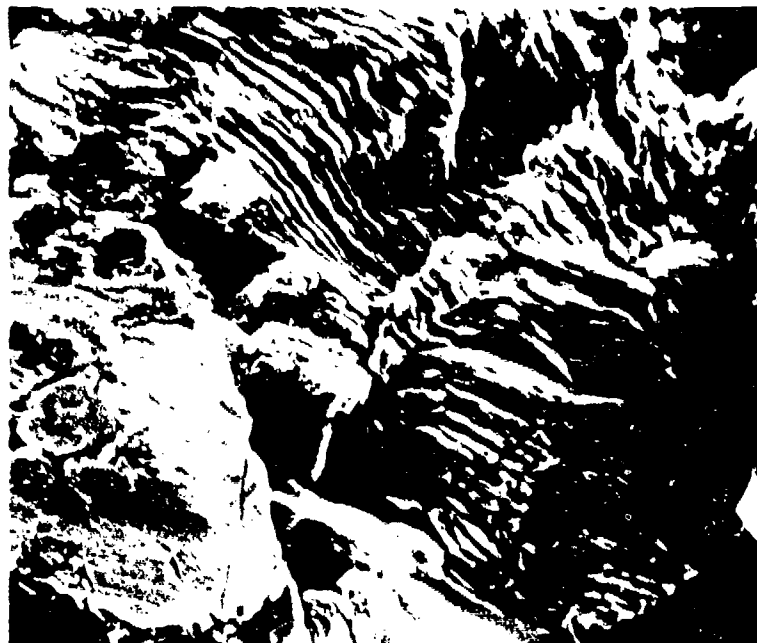
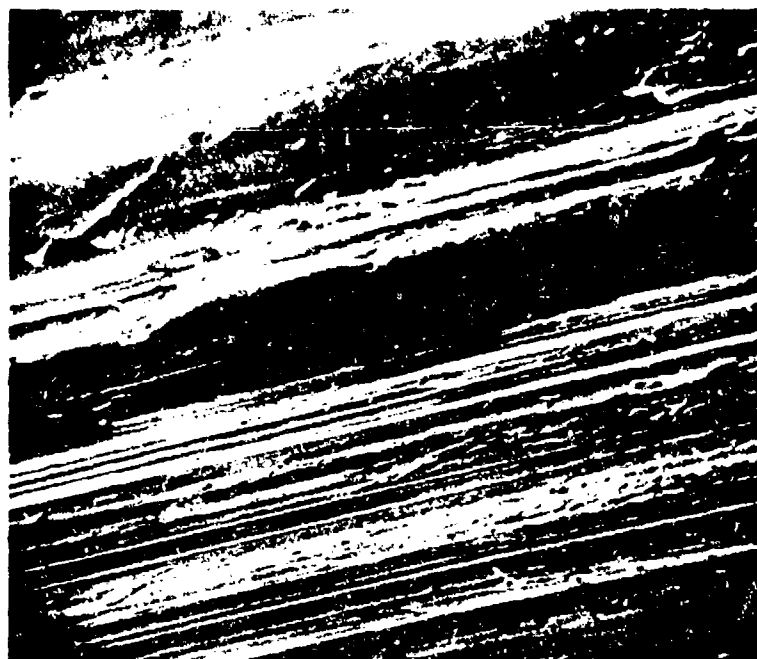
The fracture surface was cleaned and observed with an AMR 900 SEM for characteristic features. The weld metal on the surface had a granular appearance as shown in Figure A7. Hot cracks, which are significant in that they can reduce the fatigue life considerably, were observed. The hot cracks were pronounced and appeared deep when observed under a stereoscope. The SEM micrographs were taken in Zone 1 of Figure A3. The fatigue striations were observed in weld metal and in base metal as shown in Figure A8a. The fatigue striations in the weld metal were wavy and appeared to follow colonies of pearlite (Figure A8). The fatigue striations in the base metal were rather long and straight. (Figure A8b).

Figure A8. Fatigue striations.

(a) Weld metal in the surface (1600x).

(b) Bulk metal in the shaft (650x).

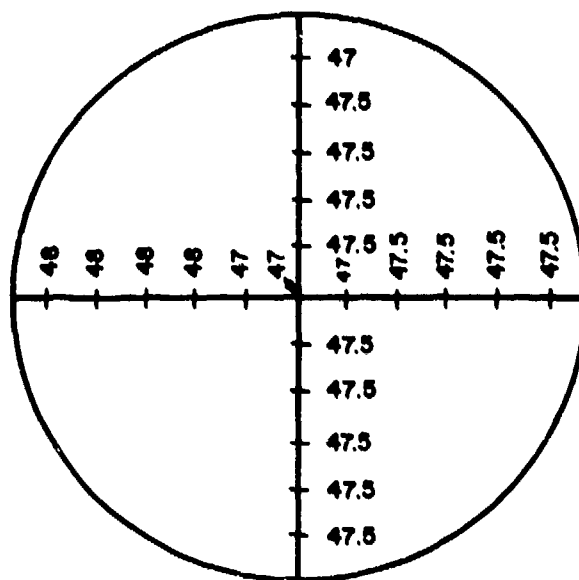
THE NUMBERS SHOW ROCKWELL C HARDNESS.

Figure A16. The hardness traverse of the spring No. 21, 1/2 in. (1.27 cm) from the fracture surface.

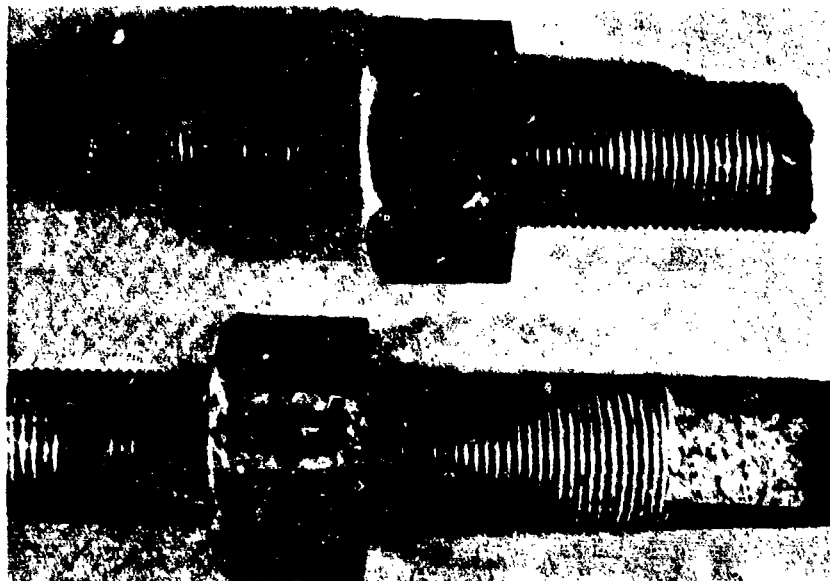
Figure A23. Fractured bolts as received by CERL.

Tempering Temperature: 1100°F to 1200°F (593°C - 649°C).
5. The fillet radius between the bolt head and shaft should be increased to reduce the stress concentration.
6. The cables should be adjusted by repeated cycling until a uniform tension is achieved.
7. It was also recommended that Carpenter 450, a precipitation hardened steel, be used instead of the AISI 416. The quality control requirements for heat treatment are not required, as is the case for AISI 416.

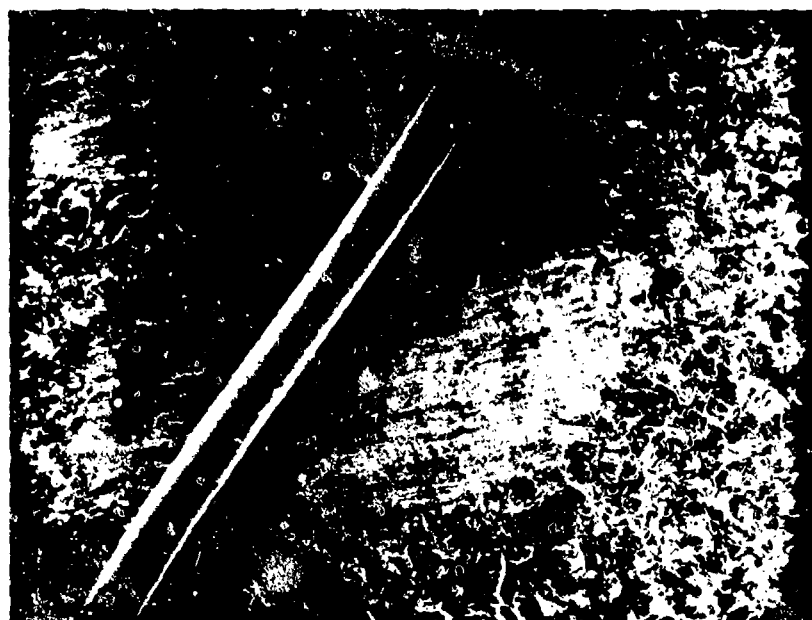
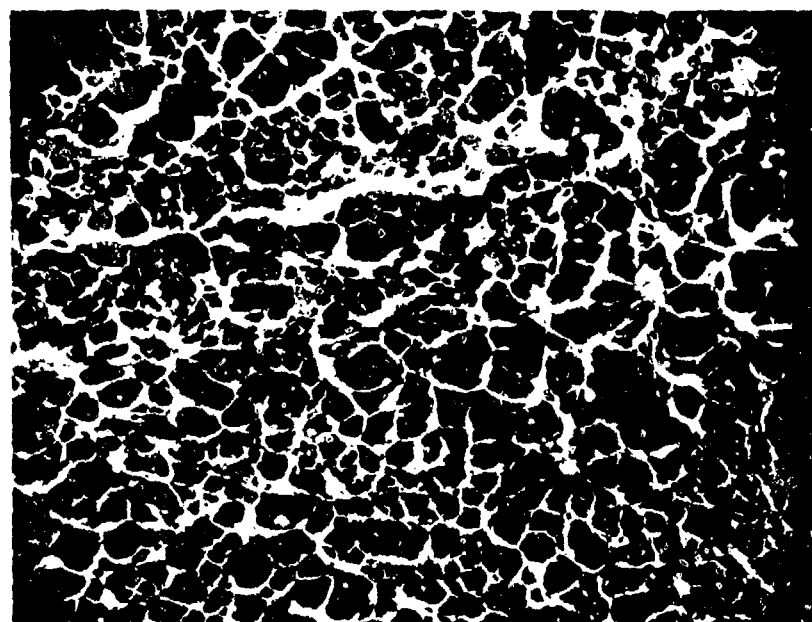
Figure A32. SEM photograph of the fracture surface of tensile specimen No. 4. The "flat spot" in the weld zone where the fracture initiated is shown. The fibrous fracture around the spot can be observed. The gold wire was used as a marker (a). The structure of the "flat spot" is shown under higher magnification (b).

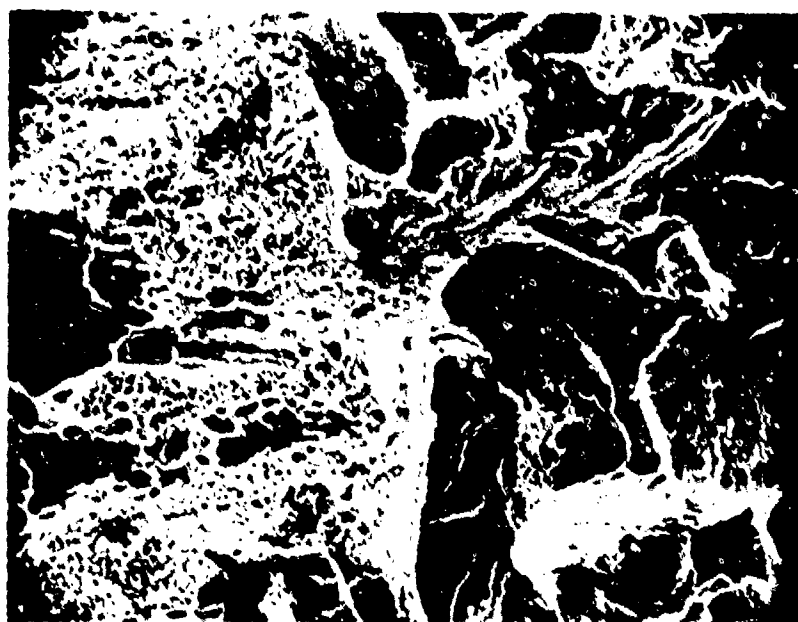
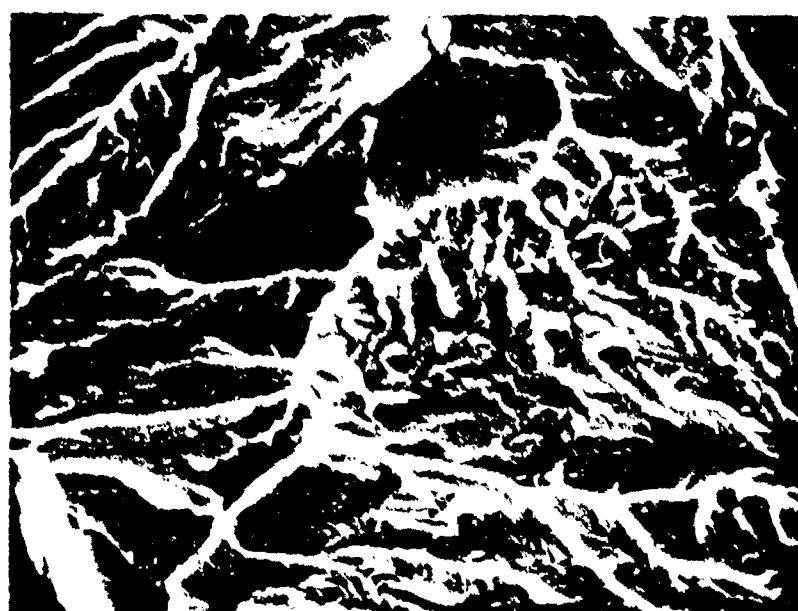
Figure A33. SEM photograph of the fracture surface of tensile specimen No. 4 (a) which failed in the weld zone. The area shown has features typical of the fracture surface away from the "flat spot" parent rail metal (b) pulled to fracture in tension.

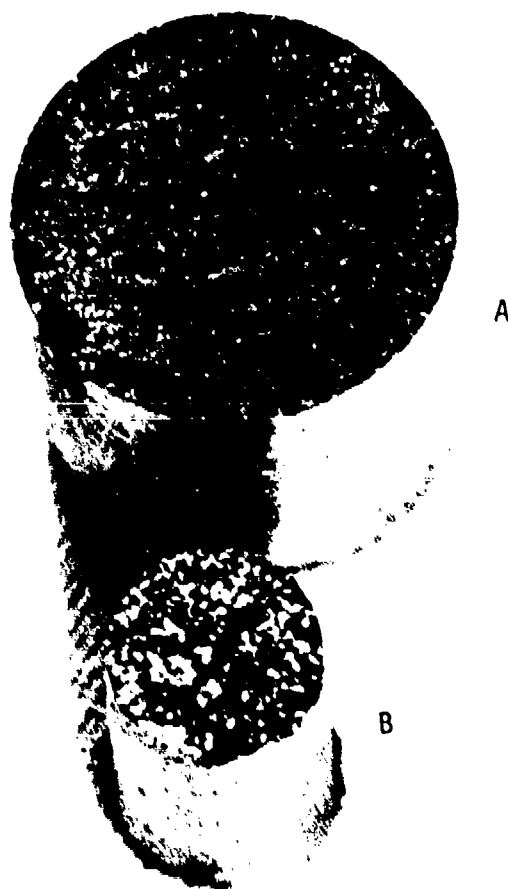
Figure A35. Fracture surface of tensile specimen No. 3 (a). Specimens machined from the welded joint failed in the weld zone showing a smooth fracture surface with a flat spot. Specimens machined from the parent rail metal (b) show fibrous fracture surface.
